Mobile Intel[®] Pentium[®] II Processor Specification Update

Release Date: April 2002

Order Number: 243887-039

The Mobile Pentium[®] II processor may contain design defects or errors known as errata which may cause the product to deviate from published specifications. Current characterized errata are documented in this Specification Update.

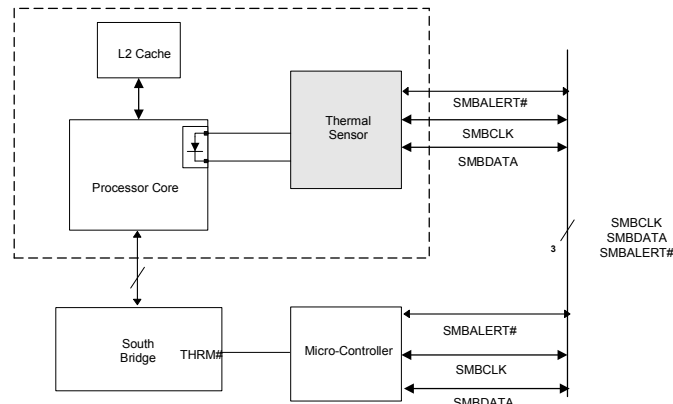
Figure 1. An Example of Microcontroller Driven Thermal Management

B30. Thermal Sensor May Assert SMBALERT# Incorrectly

Problem: The Mobile Pentium II processor and the Pentium II Processor Mobile Module have a thermal sensor that monitors the processor core's temperature. Please note that desktop systems could have a similar thermal device. The thermal sensor asserts SMBALERT# if the processor temperature exceeds the temperature limits set in the Alarm Threshold Registers (T_{HIGH} , T_{LOW}). It also sets the corresponding Status Register bits to identify the cause of the interrupt. Figure 1 gives one example of the how the SMBALERT# signal could be used in a system.

Under the conditions described below, the thermal sensor incorrectly generates the SMBALERT# interrupt. All of the following conditions must be met to trigger a false interrupt:
